Field Impact Isolation Performance of a High-End Apartment Floor

Abstract

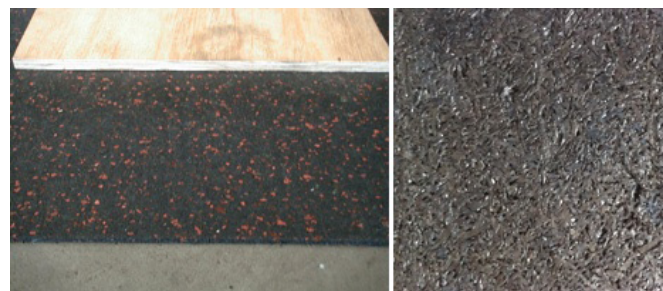
Figure 3. Rubber underlay

A rubber underlay was specified for this project. This product consists of flexible rubber sheets made by bonding long, thin rubber granules together to form a rubber mat. The granules are bound in a relatively open matrix with air spaces between the chips [5]. The resilience of the product is considered to depend on the resilience of the rubber itself and the air spaces between the chips. Field test data provided by the manufacturer showed that an improvement of $\Delta IIC 14$ could be expected when the performance of a bare slab is compared to a floor covering of 12 mm Tasmanian Oak floor on a resilient underlay[4].

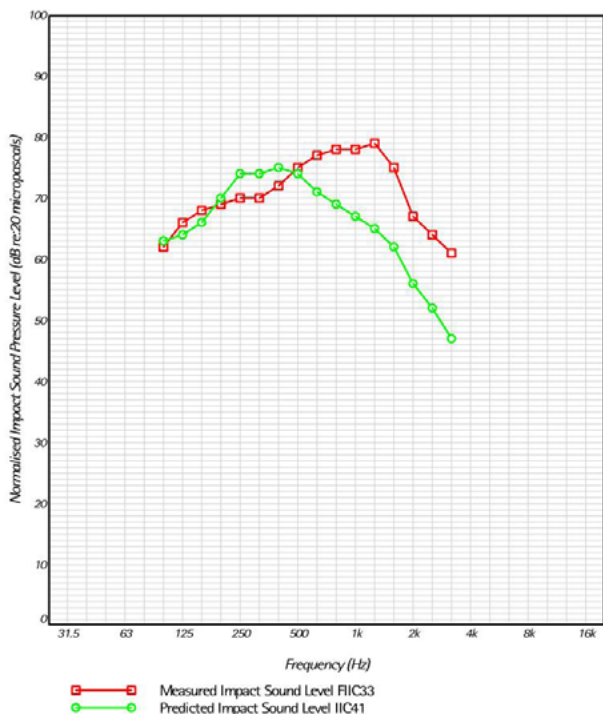
Figure 4. Comparison between measured and expected impact sound pressure levels

Figure 4 illustrates the difference between the measured and expected impact isolation provided by the floor system.

It can be seen that the level of impact isolation for the floor system insitu is significantly lower than expected between 630 and 3150 Hz. The shortfall in performance

is around 20 dB at 1 kHz.

Impact noise levels would be expected to decrease from around 250Hz onwards, however in this case impact noise levels increase with frequency between 250 Hz and 1 kHz.

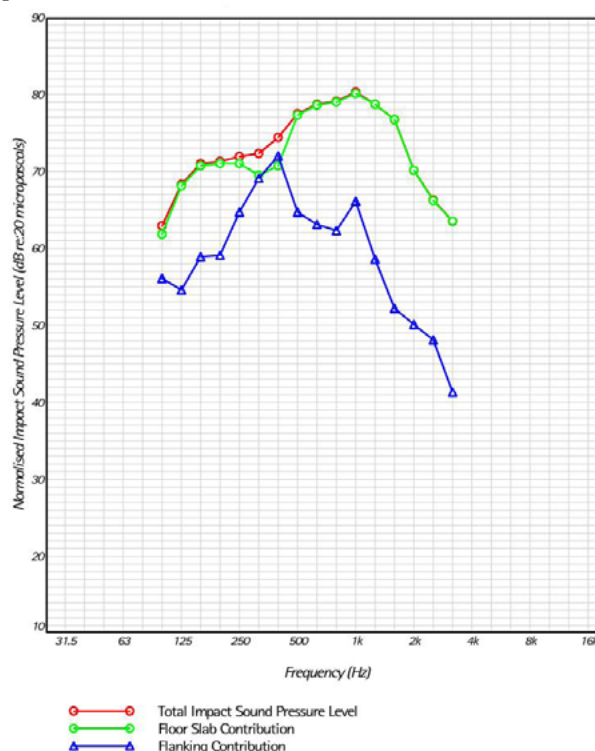
Figure 5. Calculated vibration contribution (from measurements)

The results showed that the main path of impact noise transmission was via the floor slab. However it was noted that flanking transmission was occurring via the plasterboard and masonry walls and other building elements (e.g glazing) and that these may contribute to the overall level once the ceiling was in place. Figure 5 illustrates the measured and calculated contributions to the overall impact sound pressure level without a ceiling in place.

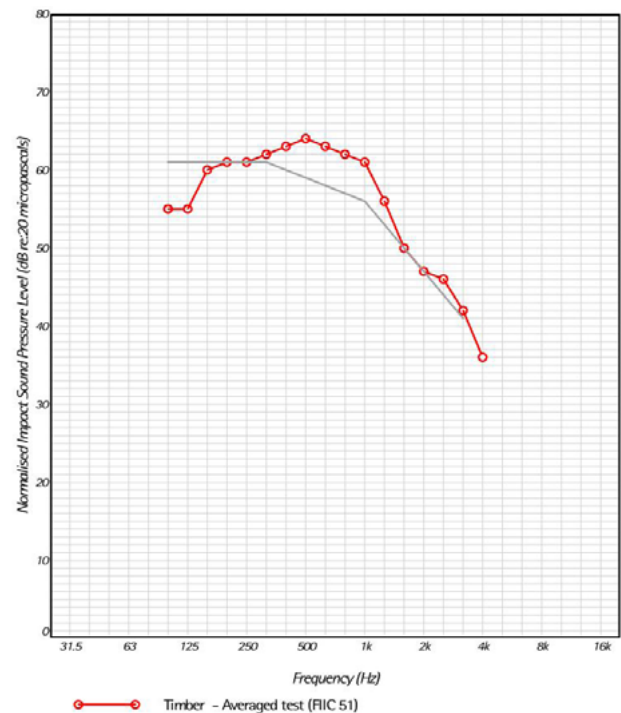
Figure 9. Normalised impact sound pressure levels with ceiling and wall linings in place (FIIC51)

Final measurements performed by Marshall Day Acoustics

and the Council contractor showed that the above constructions achieved FIIC51. This performance just complied with the Building Code minimum of FIIC50 but did not achieve the high level of sound insulation recommended for the apartments.

- Ceiling to consist of 2 x 13 mm dense plasterboard (e.g. Gib Noiseline or similar) on steel suspension incorporating resilient clips at 900 mm centres (e.g. ST001 clips or similar). 75 mm thick thermal insulation in the cavity)
- External wall linings to be 13 mm thick standard plasterboard on resilient clips (e.g. ST001).
- Internal wall linings as standard. Any full height framing to be resiliently isolated at the head of partition using partition supports at 400 mm centres (e.g. Masons MPS)
