# Evaluation of occupational workplace noise levels in an enclosed workshop at KiwiRail

*An occupational workplace noise evaluation was carried out in the engineering shop and locomotive stripping and preparation areas of KiwiRail shop in Hutt City. Five hand draw cutting saws were evaluated. Measured sound pressure levels (at the position of the operator's ear) increased substantially for four of the saws as they were put under load. Overall the measured sound pressure levels ranged from 88 dB to 101 dB  $L_{Aeq}$  for the duration of trial. One saw emitted a sound pressure level of 101 dB  $L_{Aeq}$  unchanged when operating under free running conditions and loading.*

Original peer-reviewed student paper

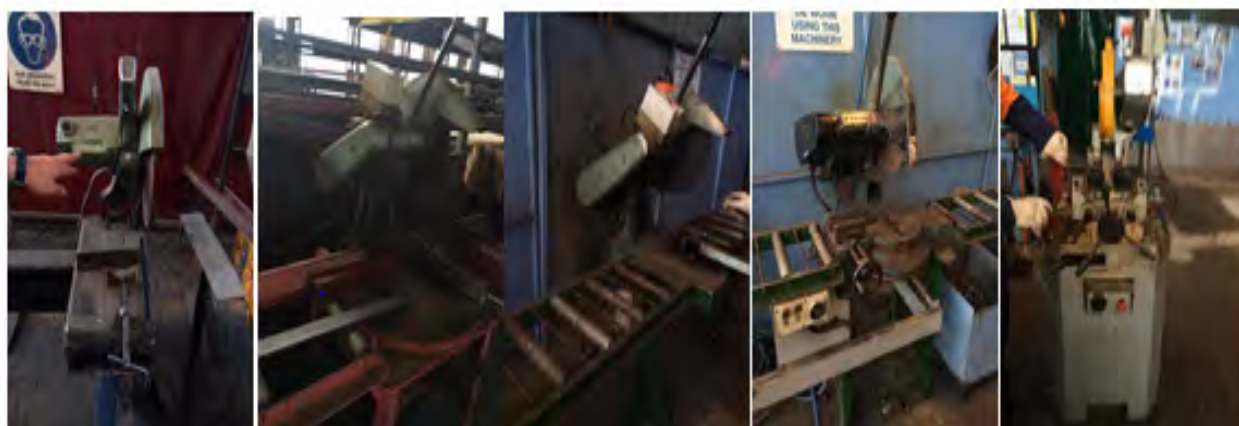
Figure 1: The cutting draw saws assessed

Five cutting draw saws were evaluated in free running (idling) and under load (cutting) conditions. The results are given in Table 1 and the saws are shown in Figure 1.

The measured sound pressure levels emitted increased significantly when the tools were placed under load except the Friction cut saw A where the sound pressure levels emitted were similar in the free run and under load conditions.

A) 10042578

B) 8630

C) 1055

D) 7534

E) 20120505

Description	KR ID # No	Free run dB L <sub>Aeq</sub>	Under load dB L <sub>Aeq</sub>
Friction Cut Saw (A)	10042578	100	101 dB
Friction Cut Saw (B)	8630	74	*91 – 100
Machine Saw (C)	1055	77	88
Machine Saw (D)	7534	71	92
Cold Saw (E)	20120505	70	83

higher sound pressure levels and were potentially more hazardous than others. In cases such as the Friction Cut Saw A, where the L<sub>Aeq</sub> was measured at 100 dB, there is a risk of permanent hearing damage after a maximum time period of 15 minutes usage of this machine without adequate hearing protection. This saw caused significant speech interference as it was nearly impossible to maintain communication between those present without shouting which suggests the level of noise emitted was high. This demonstrated that a potential hazard is not just to the person using Saw A, but consideration needs to be given to others working nearby that may not normally use hearing protection. Noise can also be potentially hazardous to other employees other than the machine operator using the Saw due to the residual noise effects. While hearing damage is dependent on an individual’s susceptibility, it is considered that when the level of noise is in excess of the recommended criterion noise level, hearing damage may begin to occur depending on the length, and level of exposure. Saws with results close to L<sub>Aeq</sub> of 85 dB should also be included in future detailed assessments as set out in the Occupational Noise Management Standard AS/NZS 1269-2005 in order to verify if they do present any

hazard under typical use. Cold Saw E had the lowest levels, causing some speech interference when under load.

- Detailed measurement and assessment on the saws and cutting equipment that were measured and discussed in this report. This will verify the level of risk created by these tools.
